**Presentation to the Clean  
Environment Commission on the  
Regulation of Lake Winnipeg**  
by  
**Jon Gerrard**  
MLA – River Heights

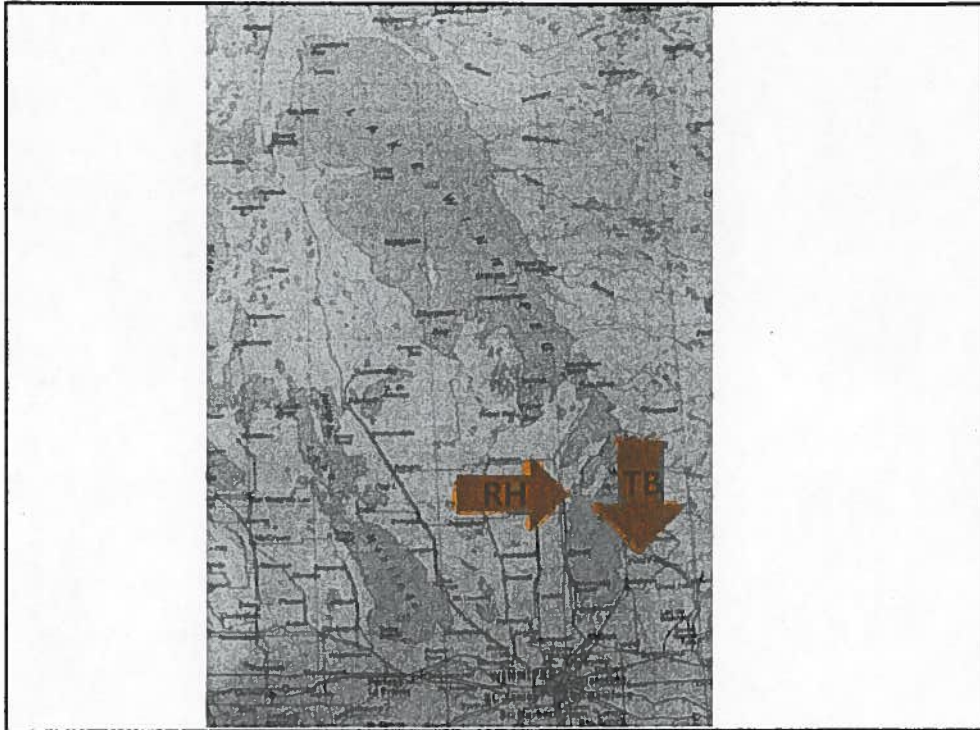
The two areas are noted on this figure – Traverse Bay and Riverton Harbour. Examples of infrastructure being considered for their impact include, the dams along the Winnipeg River starting in 1906, the Grand Rapids Dam on the Saskatchewan River completed in 1968, the Hecla Island Causeway completed in 1971, and the JenPeg Dam completed in 1979.

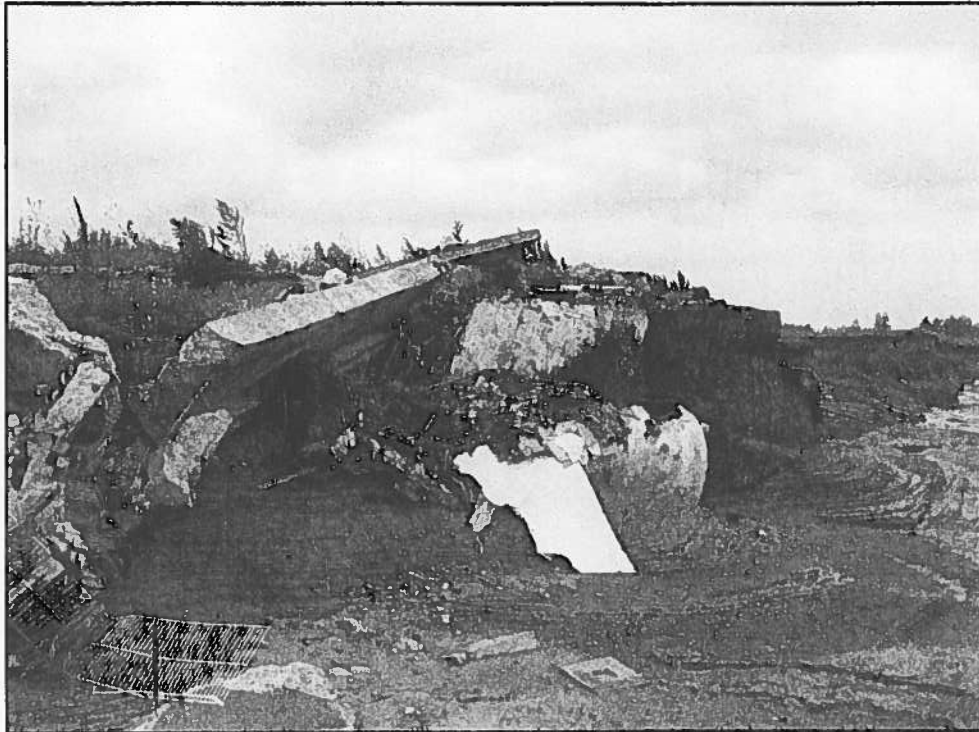
I was also there in the fall of 2007 shortly after winds and waves combined to cause this dramatic destruction of the foundation of this house. This resulted from a single severe fall storm that eroded the bank by 15 meters and caused the foundations of this home to fall from on top of the bank down to the water's edge.
