T-PVS/Inf (2003) 15

**Protecting Birds from Powerlines :
a practical guide on the risks to birds from electricity
transmission facilities and how to minimise any such adverse
effects**

*Report written by BirdLife International
on behalf of the Bern Convention*

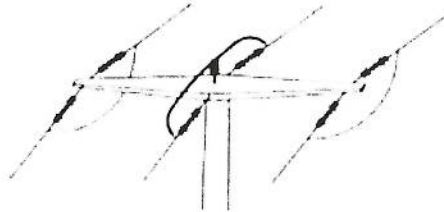
Suggested practices:

Insulated hood or insulated tubing (c)
(see also Fig. 30)
